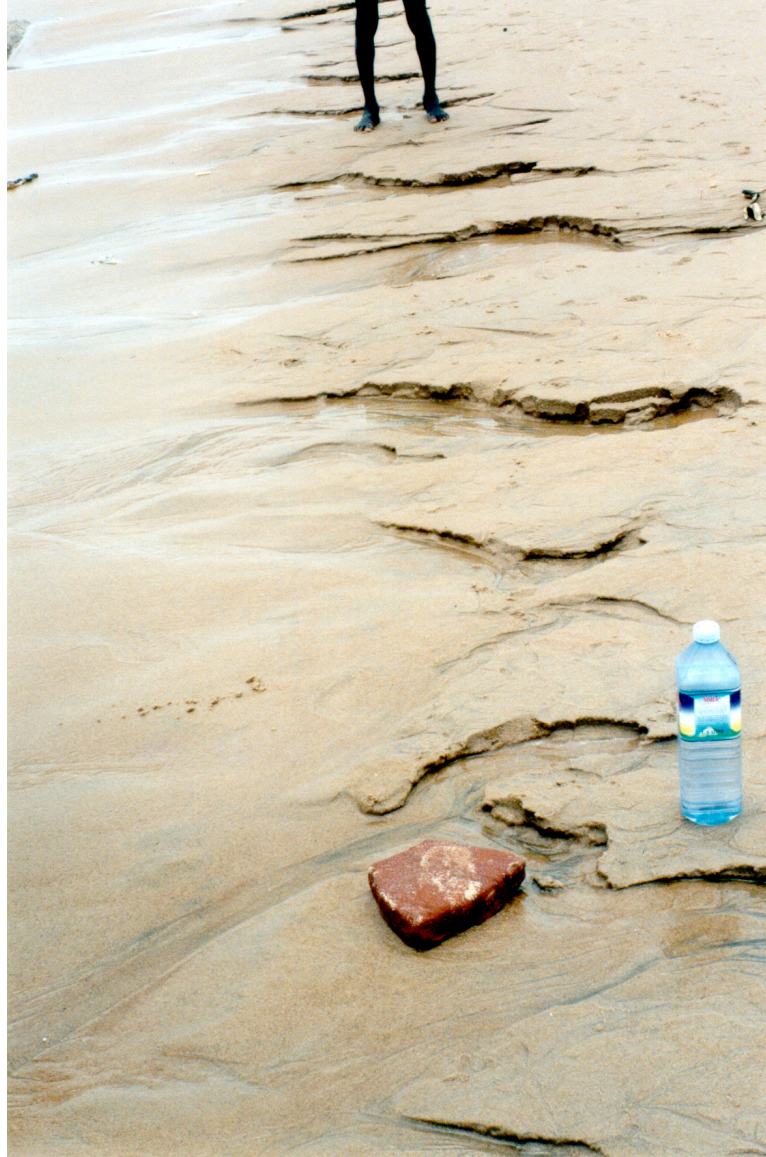
(c) Springs or surface runoff across a beach. Figure III-5-4 shows springs near the waterline along the beach in Ghana which result from groundwater flow over the impervious underlying clay and peat sediments. In this case, the groundwater flow gradient is driven by the presence of an enclosed lagoon with water levels higher than mean sea levels on the other side of the washover terrace.

Figure III-5-4. Springs flowing over the beach surface along the Keta shoreline in Ghana, West Africa, September 1996
